# Traffic Volume and Accidental Studies on State Highway-19 between Ghumarwin to Kuthera District Bilaspur, Himachal Pradesh

**Index Terms** — Traffic Volume and Accidental Studies, Blackspots, State Highway-19, Ghumarwin to Kuthera District Bilaspur, Himachal Pradesh

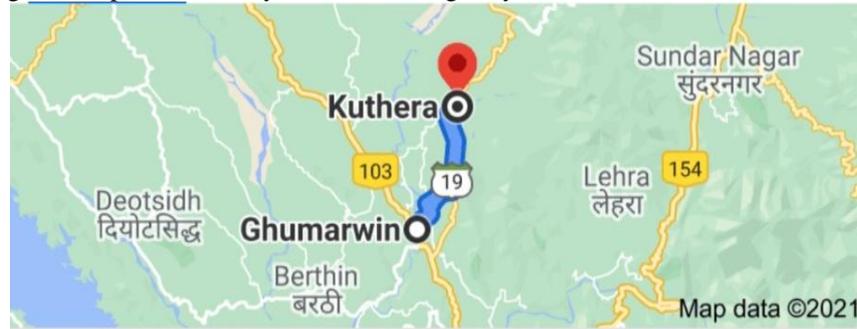
Fig. 1- The picture of study area at State Highway-19 between Ghumarwin to Kuthera

21 min (10.6 km)

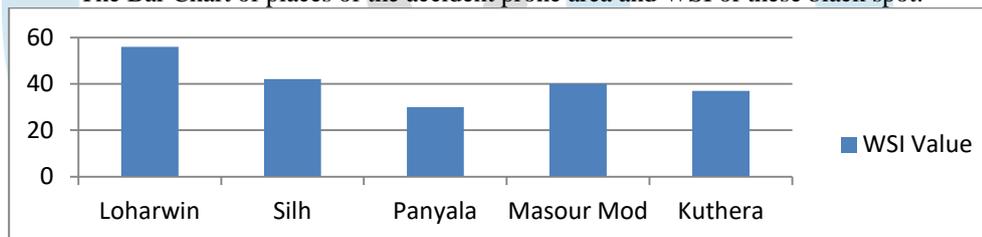
The Bar Chart of places of the accident prone area and WSI of these black spot:

**Graph 1: Bar Chart of Accident prone area and WSI Value**

In the above the Five Black spot places are found between Ghumarwin to Kuthera on state highway-19 by using WSI method. The Places of the Black spot with their Accident and WSI Value is table shown below:

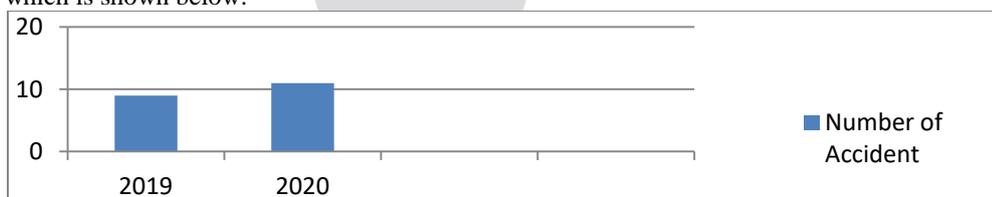
This table shows that 20 accidents took place in the past two years on state highway-19 from Ghumarwin to kuthera, and in 2020 there will be fewer accidents as compared to 2019. From the bar chart, it easy to understands the accident variation between Ghumarwin to kuthera, which is shown below:

**Graph 3: Bar Chart shows year-wise variation of the number of accident on State Highway-19**

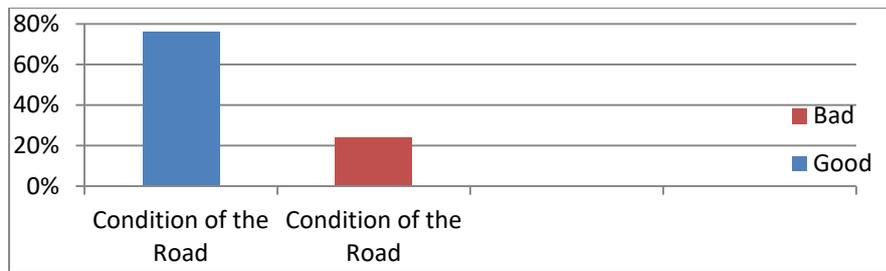
**Graph 4: Bar Chart between the conditions of the road at State Highway-19**

In the bar chart, it is clear that 76% of people say good and 24% of people say bad conditions of the road on state highway-19 between Ghumarwin to kuthera.

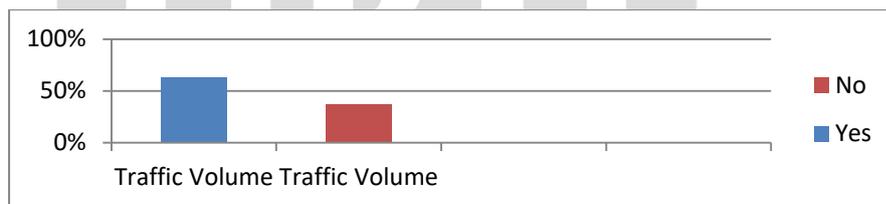
**Graph 5: Bar Chart of Traffic Volume on State Highway-19**

This Bar chart shows that 63% of people say yes and 37% say no to traffic volume on State Highway-19.

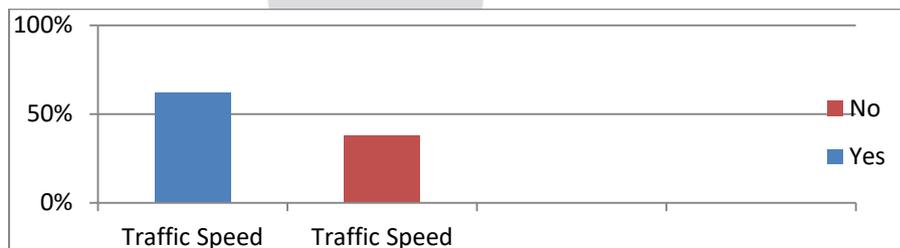
**Graph 6: The Bar Chart of Traffic Speed on State Highway-19**

This bar chart shows that 62% people say yes and 38% say no to Traffic speed on State Highway-19.

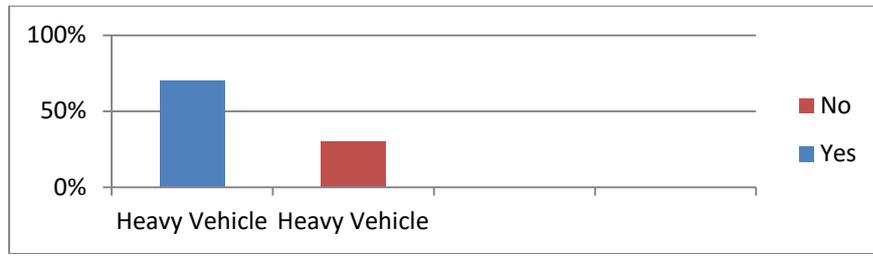
**Graph 7: The Bar Chart of Heavy Traffic on State Highway-19**

This Bar Chart shows that 70% of People say yes and 30% say no to Heavy Vehicle on State Highway-19.

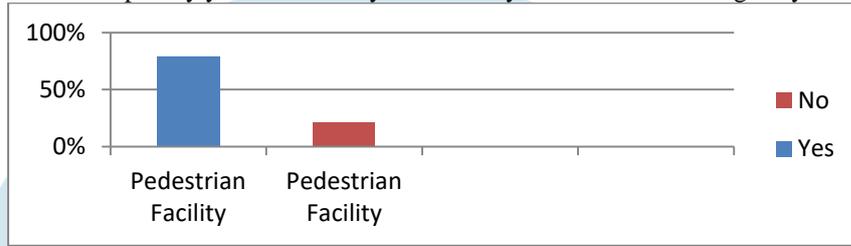
**Graph 8: The Bar Chart of Pedestrian Facility on State Highway-19**

This Bar Chart shows that 79% of people say yes and 21% say no to Pedestrian Facility on State Highway-19.

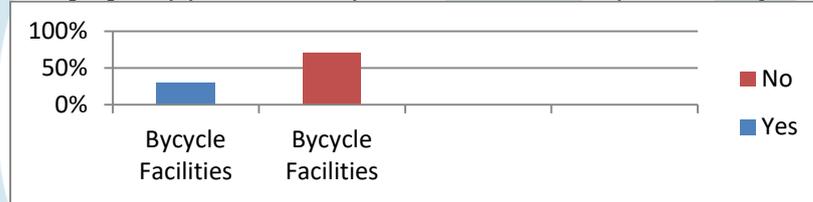
**Graph 9: The Bar Chart of Bicycle Facilities on State Highway-19**

This bar chart shows that 30% of people say yes and 70% people say no to Bicycle Facilities on State Highway-19.

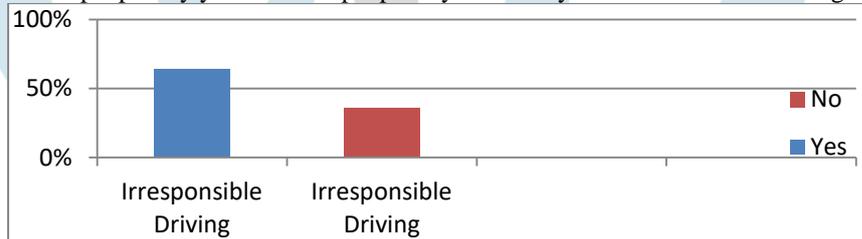
**Graph 10: The Bar Chart of Irresponsible Driving on State Highway-19**

This Bar Chart shows that 64% of people say yes and 38% say no to Irresponsible Driving on State Highway-19.

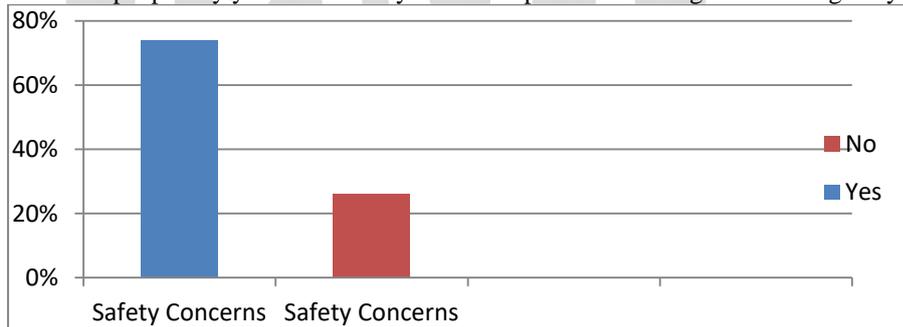
**Graph 11: The Bar Chart of Safety Concerns on State Highway-19**

This bar chart shows that 74% of People say yes and 26% people say no to Safety Concern on State Highway-19.

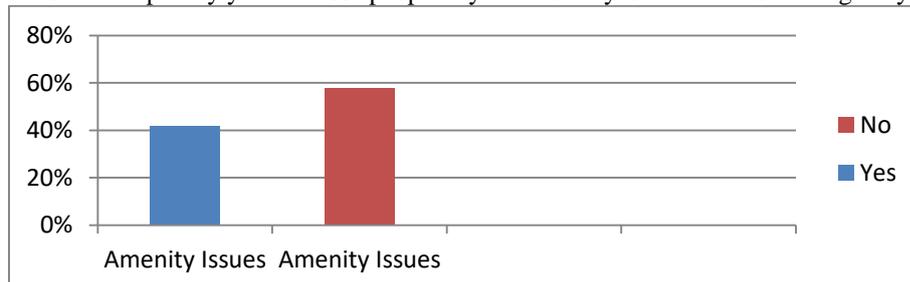
**Graph 12: The Bar Chart of Amenity Issues on State Highway-19**

This bar chart shows that 42% of people say yes and 58% say no to Amenity issues on State Highway-19.

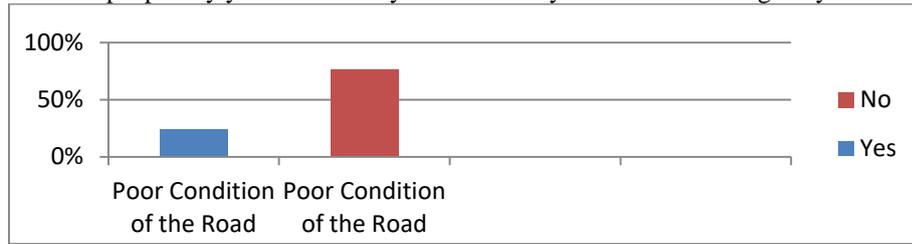
**Graph 13: The Bar Chart of Poor Condition of the Road on State Highway-19**

This bar chart shows that 24% of People say yes and 76% say no to Poor Condition of the Road on State Highway-19.

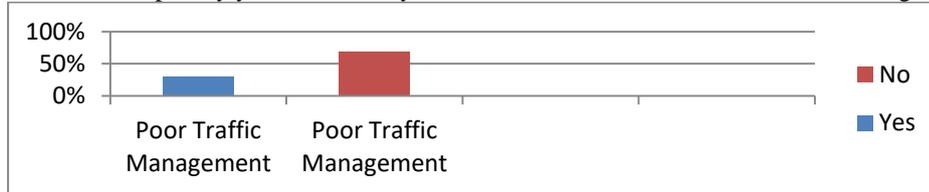
**Graph 14: The Bar Chart of Poor Traffic Management on State Highway-19**

This bar chart shows that 31% people say yes and 69% say no to Poor Traffic Management on State Highway-19.

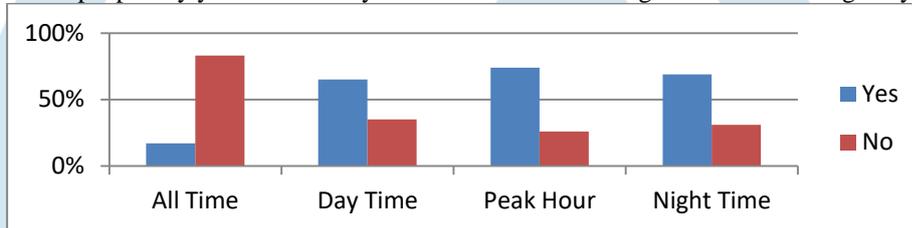
**Graph 15: Bar Chart of Problems occurs at what time on State Highway-19**

In the bar chart given above, it has been said that at which time there would be more Problems in Traffic on the State Highway-19.

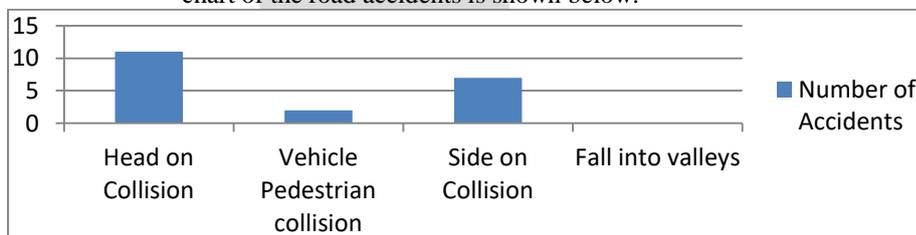
**Graph 16: The Bar Chart of Pattern of the Accident Pattern on the State Highway-19**

This bar chart shows the type of collision with the number of accidents on State Highway-19. This bar chart indicates that head-on collisions are the most common type of accidents collision.

This table indicates that head-on collision is the most common type of accident pattern, followed by side-on collision. The bar chart of the road accidents is shown below.
