Smart Technique Of Removal Of Heavy Leakage From Elevated Storage Reservoir At Majgaon, Tal-Panhala, Dist-Kolhapur

By – **Er. Rutuja Ravikant Patil.**

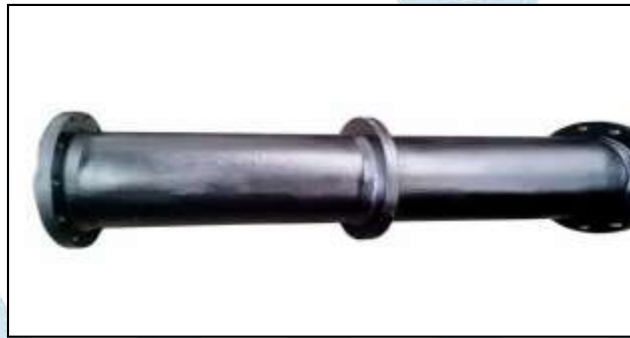
There was an elevated water tank at Majgaon, Taluka – Panhala, Dist. - Kolhapur which is constructed for the purpose of domestic water supply to the village recently. It was constructed at 12 m height from ground level in circular shape of 3.2 m internal diameter with flat slab at top and bottom. The storage capacity of water tank was 15000 litres. An outlet has to be provided to distribute water from the centre of bottom slab of the elevated water tank. Pipes for outlets have to be provided during or before the shuttering of the slab. But time for procurement of cast iron pipe was delayed, the RCC contractor was not willing to wait till then, shuttering & casting had been done for bottom slab. After casting of the slab, cast iron pipes about 900 mm dia. [3ft.] in length was delivered to the site. There was a cast iron flange present at both the ends of pipe also at the mid of the pipe. Refer (Fig.No.1). To fix the pipe, the hole of approximate 20 cm. diameter i.e. greater than outer diameter of the collar was drilled and the pipes were fixed in the slab after setting & hardening of RCC slab. The remaining gap was filled with concrete around cast iron pipe for outlet.

Fig.No.1 – Cast iron pipe with flange (collar) at top, middle and bottom

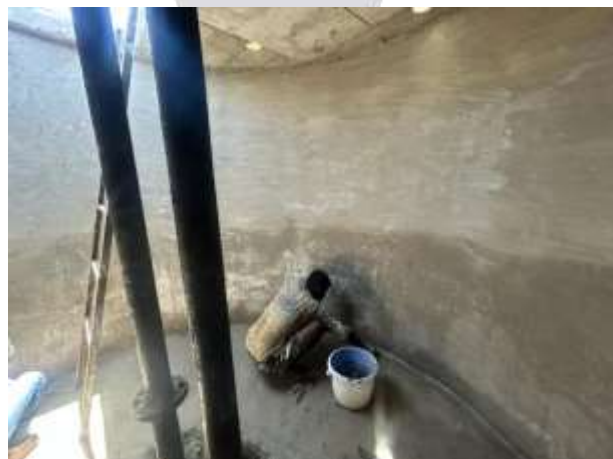
It has created the cold joint between concrete of bottom slab of water tank and the concrete used for filling purpose of drilled hole. Also the joint between the cast iron pipe and the concrete was weak as it was not properly vibrated after casting. Because of the work done in multiple phases, it is not allowed the rest of the slab and the concrete filled near the drill to become a homogenous. Due to this, the problem of large scale water leakage started at the junction of pipe and bottom slab. As per villagers, approximately within 15 to 16 hrs the whole water tank was getting empty. Approximate rate of leakage was 2.77 litres/seconds] Also, small cracks were observed at some places in the wall of the water tank. That was an emergency to fill that cracks immediately to stop water leakage problem as the water tank is the main source of distribution of water at the village & also to avoid corrosion of reinforcement in the RCC slab at bottom from the safety & durability point of view.

Fig. No.2- Detection of cracks formed in the bottom slab and walls of water tank

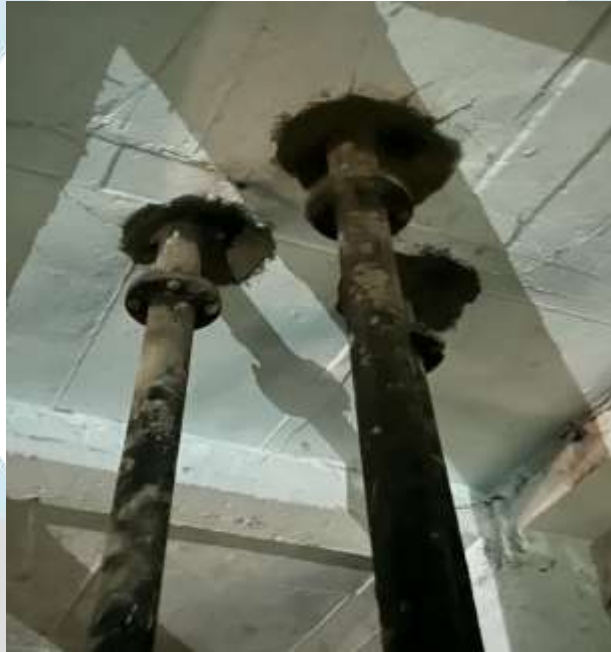
Fig.No.3- Cracks formed at bottom bottom slab, walls and joint between them are filled with

To stop the water leakage, we have used water proofing chemicals named PERMA BOND SBR & NEROLAC PERMA HYPERCRETE emulsion. PERMA BOND SBR is a high strength repair mortar and bonding agent which is formulated to mixed with cement. It is actually an emulsion of Styrene Butadiene Copolymer Latex. PERMA BOND SBR is mainly used for, to protect reinforcement steel from corrosion, water proofing purpose and to make firm connection between old concrete and new concrete. For waterproofing PERMA BOND SBR & NEROLAC PERMA HYPERCRETE are mixed with cement in the ratio by volume i. e. 1 litre of chemical for 1 bag of cement to make slurry. With the help of brush and roller applied it on the defective surface area. It can be mixed in the mortar also to make modified mortar. NEROLAC PERMA HYPERCRETE is used for specially bottom slab and PERMA BOND SBR is used for RCC wall of water tank. Refer (Fig.No.3 and 4).

To apply the water proofing chemical on structure some precautions are necessary to be taken. First clean the surface from dust and any rusting in case of reinforcement. Water proofing slurry is applied on the wet surface. Also it is applied as quickly as slurry is made because it has quick setting property.

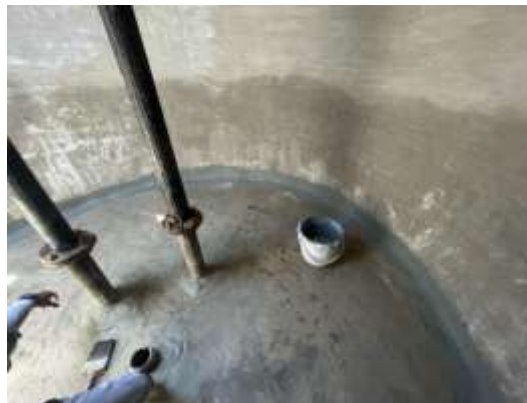
Fig. No.4 - Holes drilled in the slab for pipes are filled with chemically treated mortar

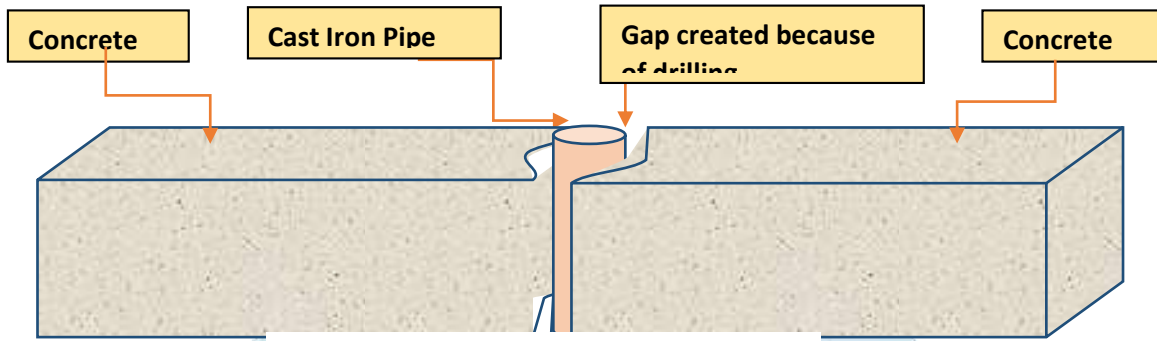
Sometimes while doing the concrete work it is not possible to place all required quantity of concrete at the same time. In such kind of cases placing of concrete is done in multiple phases. But due to multiple phase concrete work, first layer of concrete is hardened before placing of second layer because of greater time lapse between the works. It creates a gap between the two layers of concrete. Such type of concrete joint called as a cold joint. It makes two separate layers of concrete and do not form a homogeneous structure. But strength of concrete is all depends on the homogeneous nature of concrete. As good as the concrete is homogeneous it will be the best quality concrete. Many times such kind of cold joints are main cause of water leakage. Also if there is a heavy load on the structure, there are more chances to fail the structure near the cracks or cold joint. Refer (Fig.No.5).

Fig.No.5 - Cold joint between concrete layers
